### The Condition of the Aberfeldy Footbridge after 20 Years in Service

# THE CONDITION OF THE ABERFELDY FOOTBRIDGE AFTER 20 YEARS OF SERVICE

Dr Tim Stratford

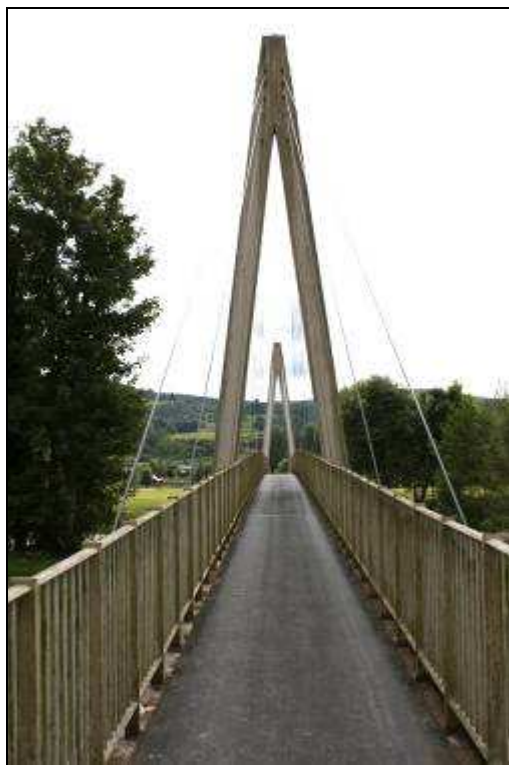
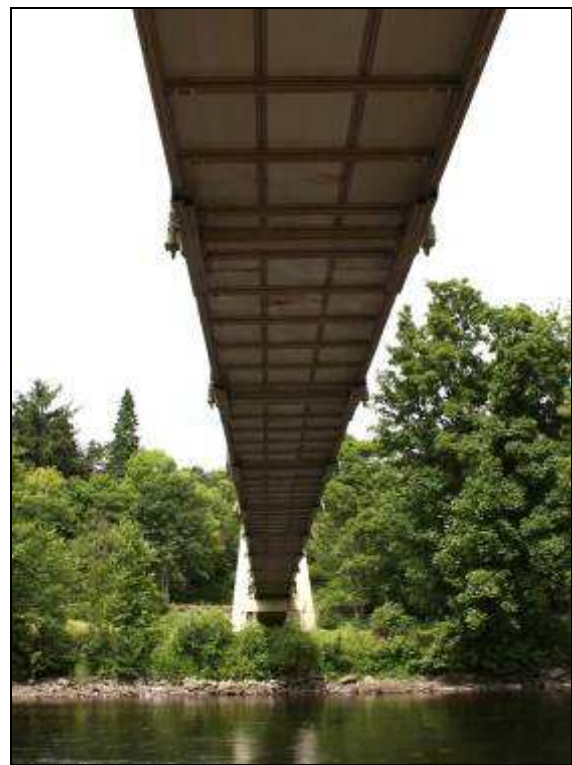
Figure 4. Aberfeldy footbridge from above and below the bridge deck (June 2008)

The parapets consist of rectangular parapet posts, top and bottom rails, and closely spaced circular vertical members (Figure 4). These were all standard GFRP pultrusions, although they were not produced to the same specification as the ACCS deck components. The parapet components consequently exhibit greater erosion of the surface veil, with many regions of exposed fibres, particularly on the bottom rail due to a combination of abrasion and weathering.
